Project: Courtyards of Carlisle CA – Siding Project

Project #: 14372-04

Date: Jan 22, 23, 26, 27, 2024

Field Report 9

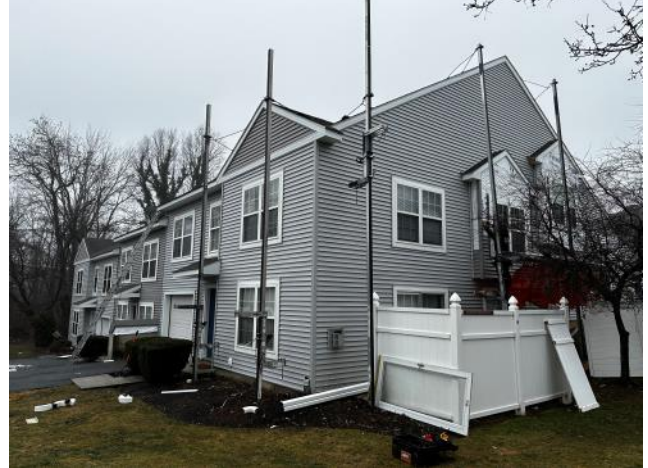
Photo #1: **Overview of Lemus Siding Crew (Blue) working at Building 5 (44-54 Courtyard Drive).**

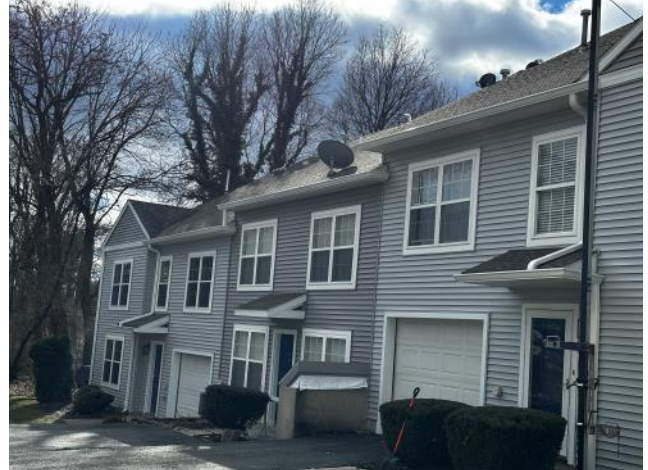
Photo #4: Overview of new vinyl siding installed at a front section of Building 5.

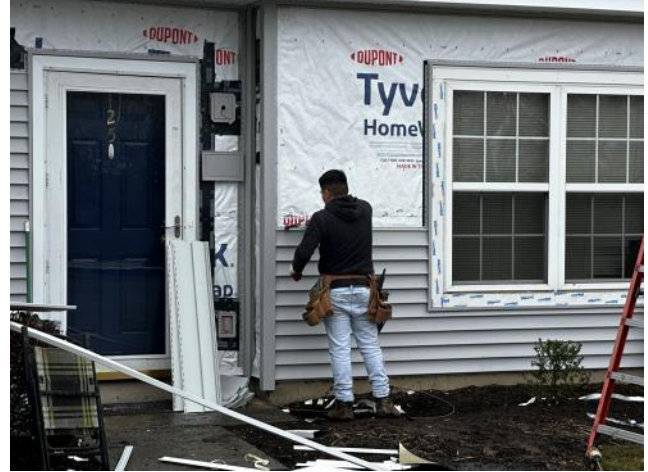
Photo #5: **Overview of Lemus Siding Crew (Yellow) working at Building 19 (19-29 Courtyard Lane).**

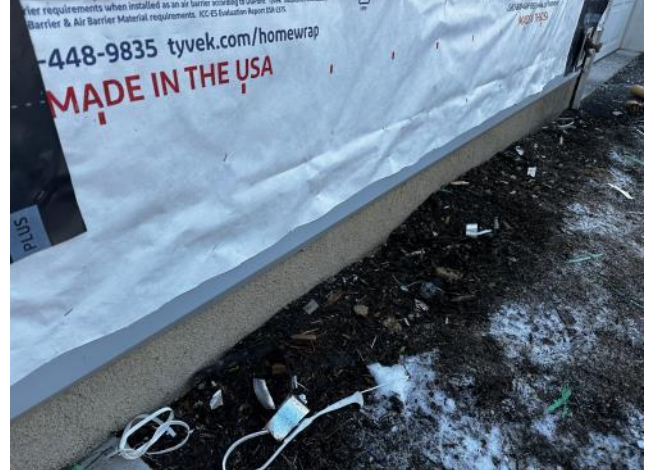
Photo #8: Overview of new starter metal flashing installed.

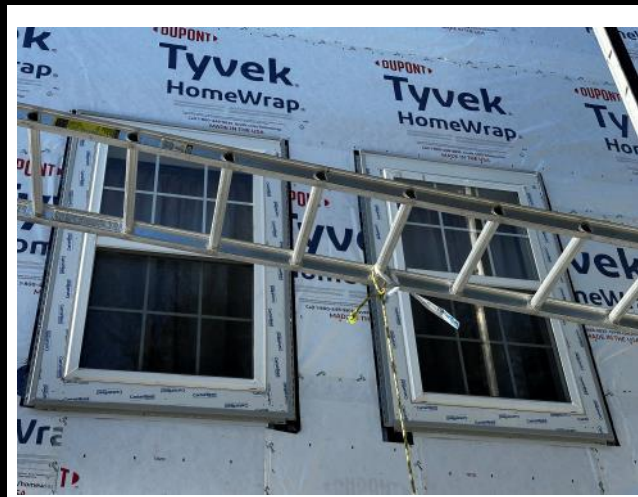
Photo #9: Overview of new pvc trim installed at two windows.

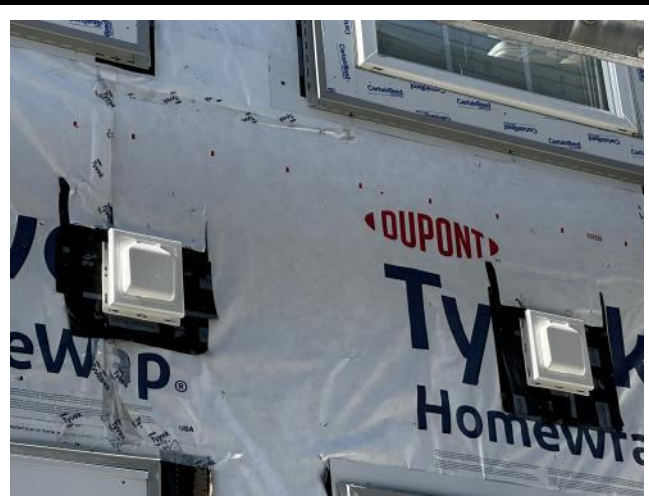
Photo #10: Overview of wall penetrations properly flashed.

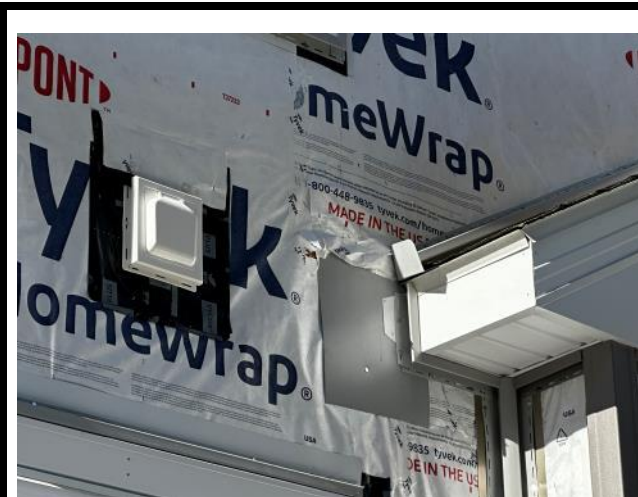
Photo #11: Overview of a new kick-out flashing and metal installed.

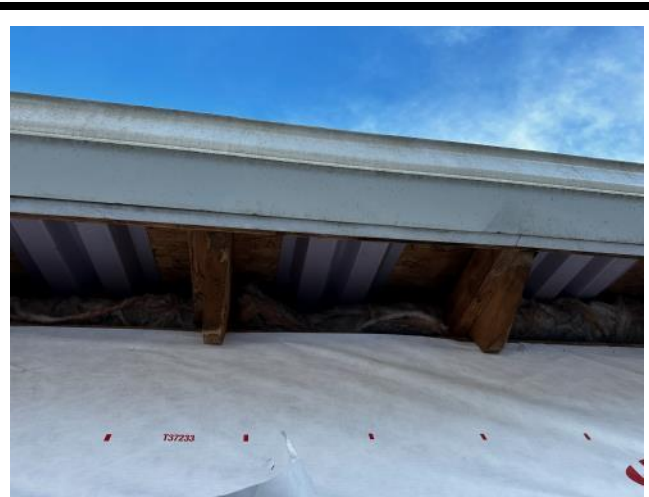
Photo #12: Overview of existing baffles that were observed in the Building.

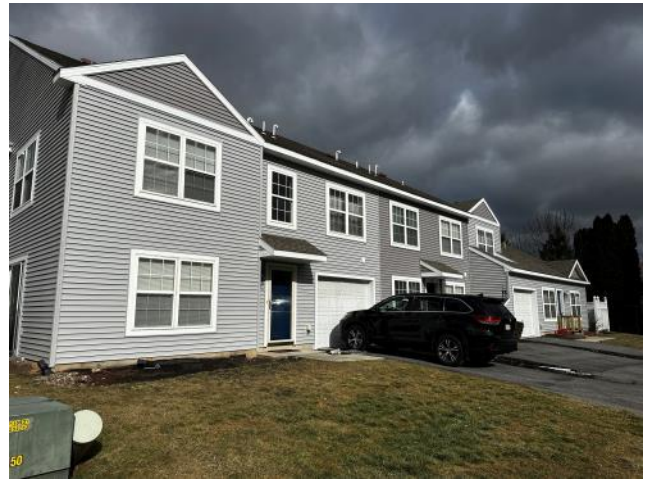
Photo #14: Overview of new vinyl siding installed at a front side of the Building.

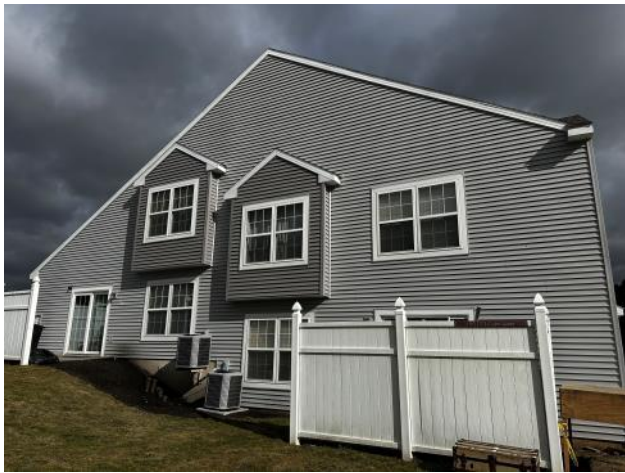
Photo #15: Overview of new vinyl siding installed at the other main side of the Building.

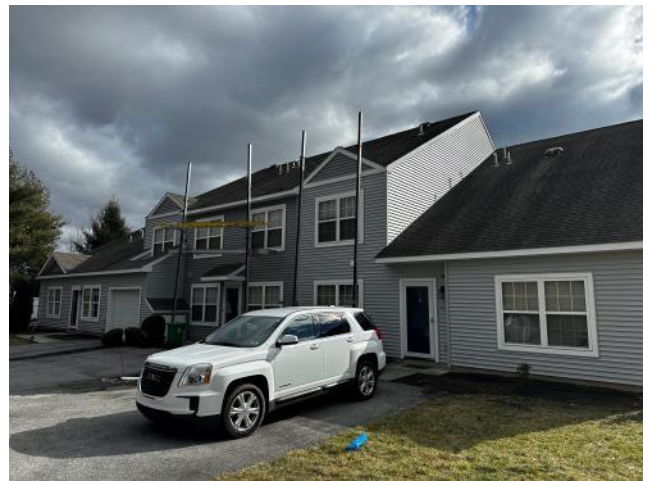
Photo #16: Overview of new vinyl siding installed at the other front side of the Building.

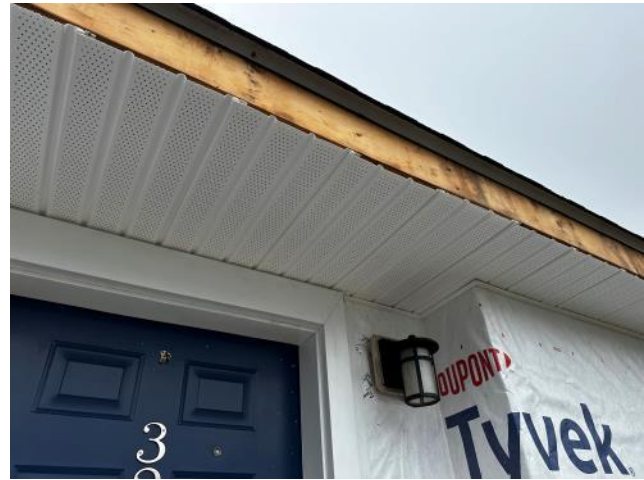
Photo #18: Overview of new intake soffit being installed.

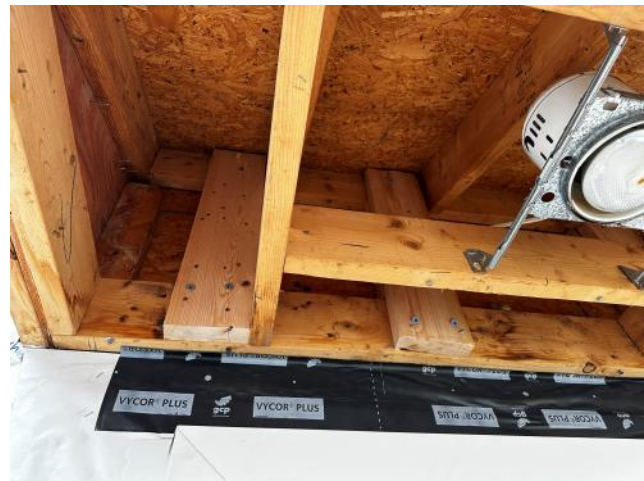
Photo #20: Overview of an entrance roof being reinforced with structural screws in order to eliminate the front brackets.

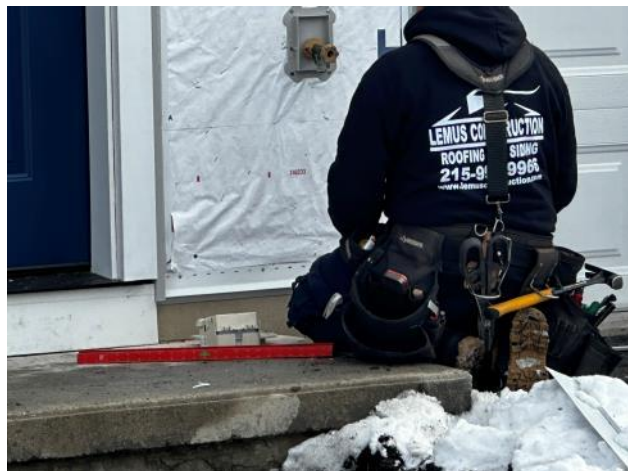
Photo #21: Overview of new starter strip being installed.

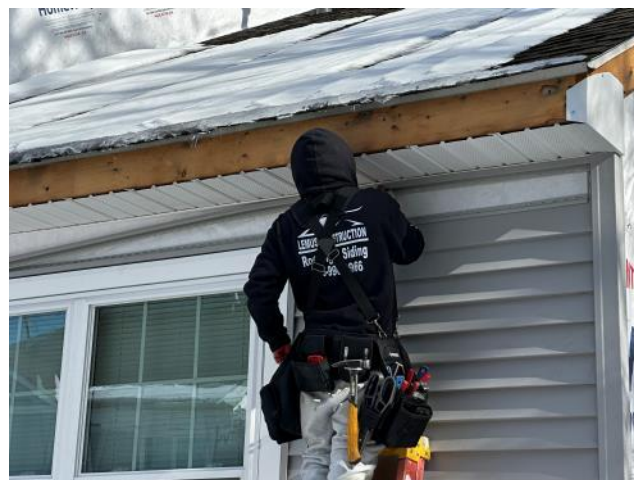
Photo #22: Overview of new intake soffit being installed along new j-channel.

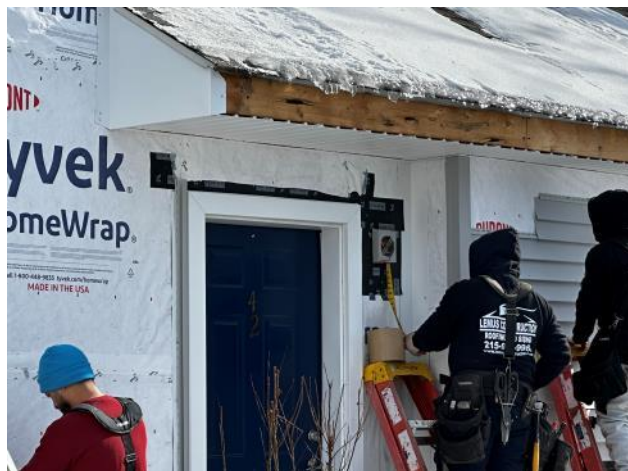
Photo #23: Overview of wall penetrations properly flashed.

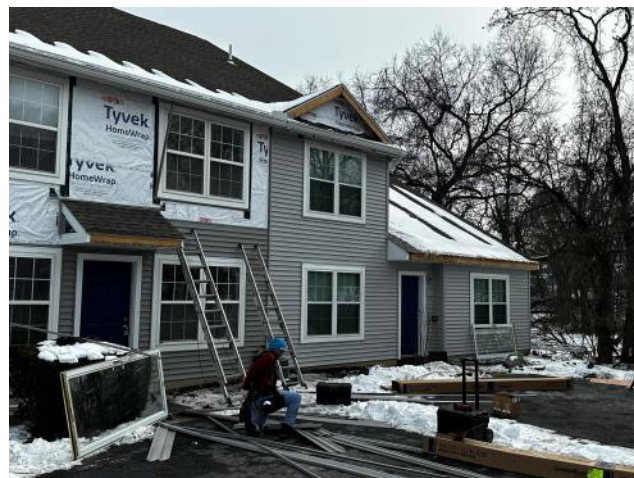
Photo #24: Overview of new vinyl siding being installed at a front section.

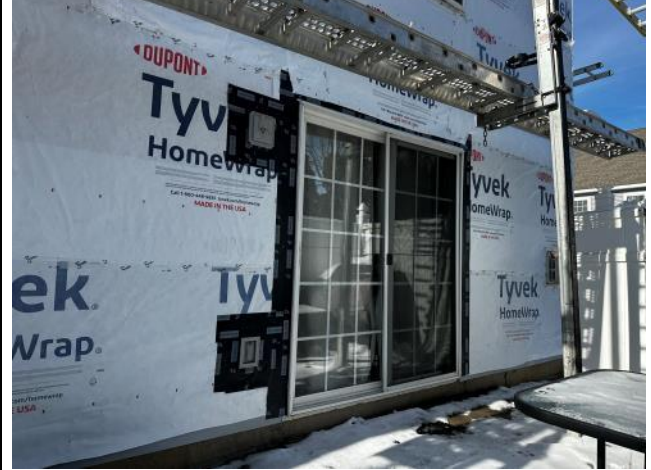
Photo #26: Overview of wall penetrations properly flashed.

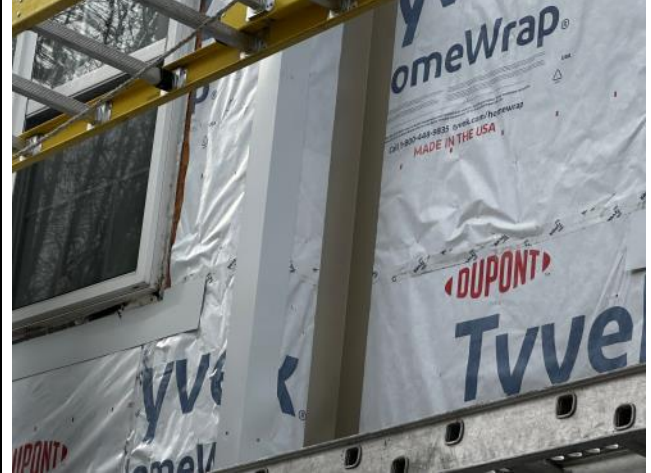
Photo #28: Overview of new metal flashing installed at the corners.

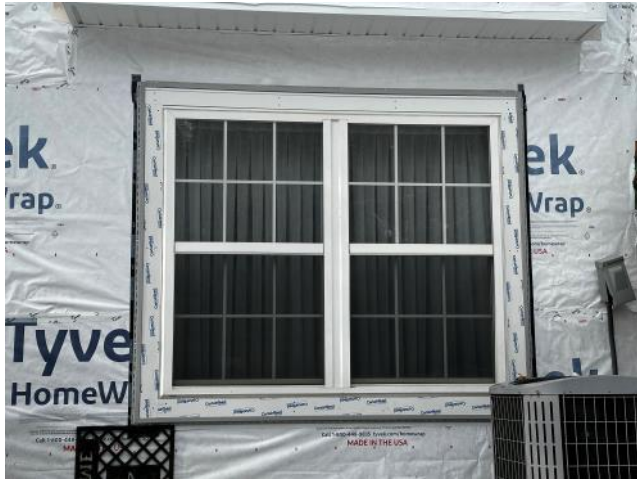
Photo #29: Overview of new pvc trim installed at a window.

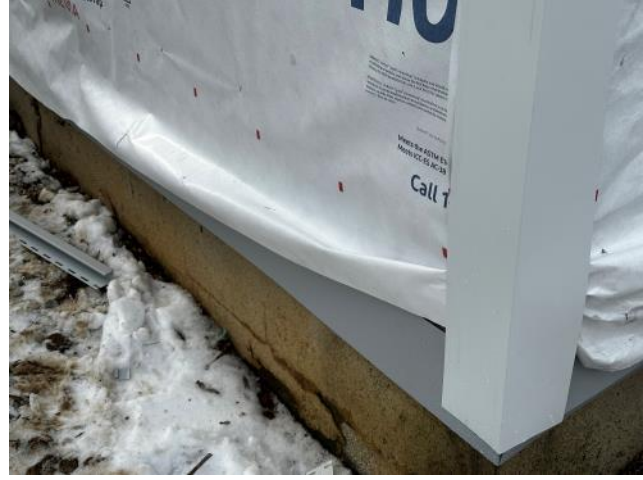
Photo #30: Overview of new starter metal flashing installed.

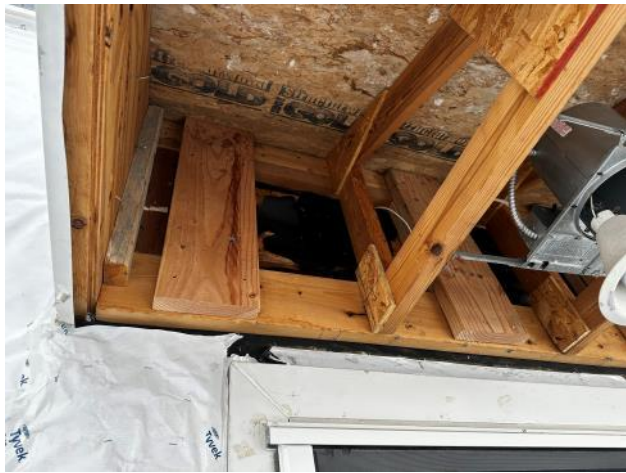
Photo #31: Overview of an entrance roof being reinforced with structural screws in order to eliminate the front brackets.

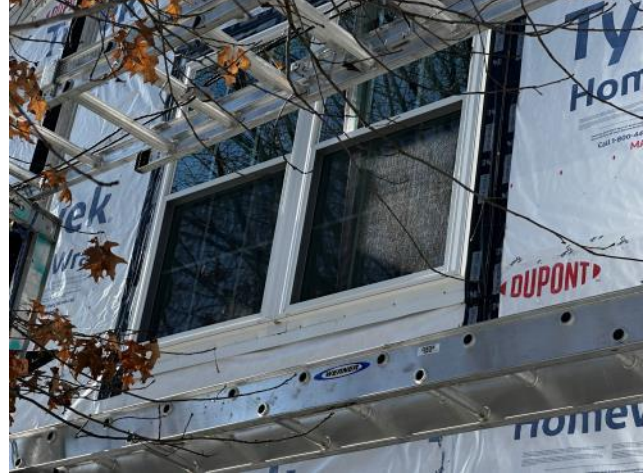
Photo #32: Overview of new metal flashing installed at the bottom of a window and new flashing tape installed at the sides.

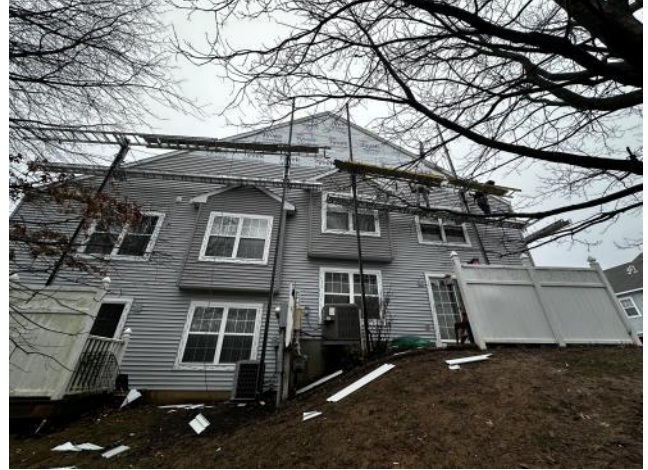
Photo #34: Overview of new vinyl siding being installed at a main side section.

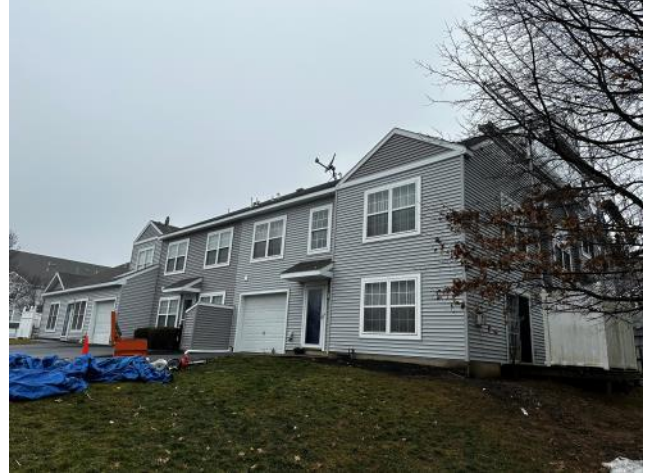
Photo #36: Overview of new vinyl siding completed at a front side of the Building.

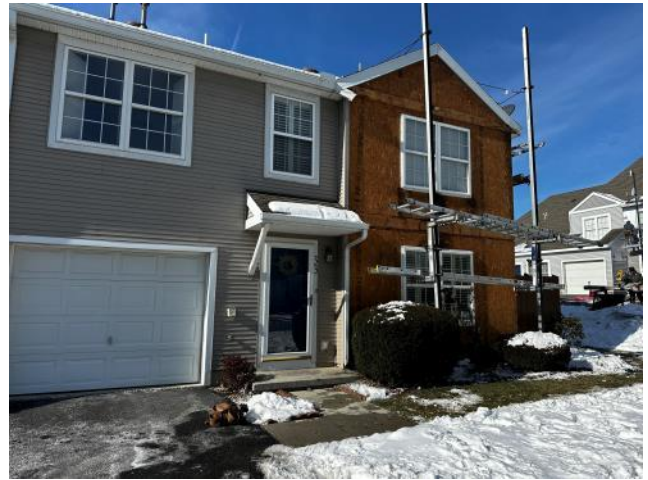
The demo & carpentry crews continued with the existing siding/stucco removal and replacing any existing damaged wood at Buildings 21, 2, and 22. It should be noted that just like the others Buildings, water resistant barrier material was not observed throughout the walls after the siding and stucco was removed and some existing windows were not properly flashed in the past. Also some existing windows were observed to be failing. Existing sheathing and framing at some sections were observed to be damaged at the bottom of those windows, including the box windows with stucco and sections where kick-out flashings are missing on the roofs.

Photo #38: Overview of existing siding being removed. No Water Resistant Barrier was observed.

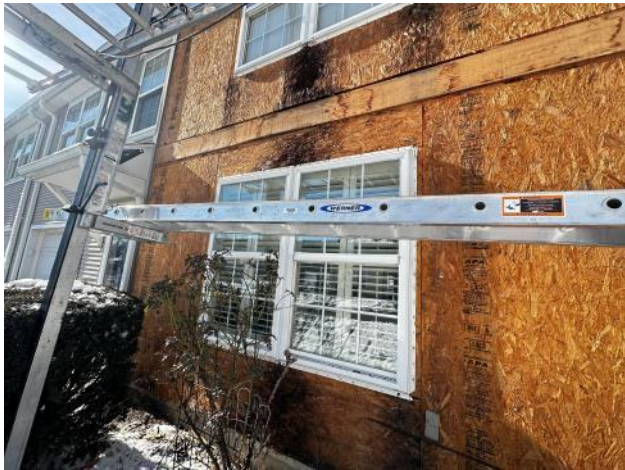
Photo #39: Overview of existing sheathing in poor condition below an upper and a lower window at Unit 33.

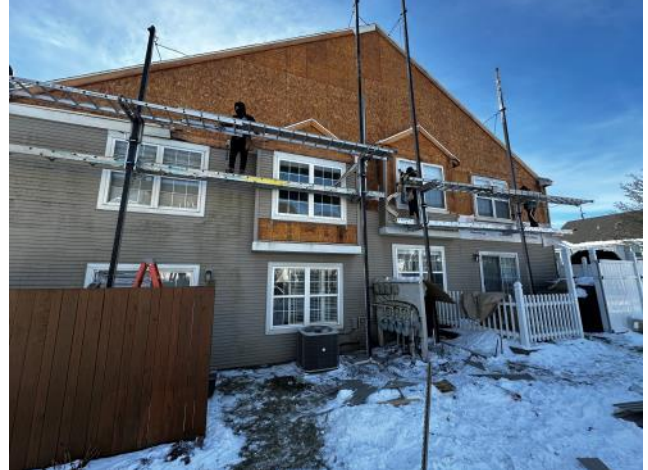
Photo #40: Overview of existing siding/stucco being removed.

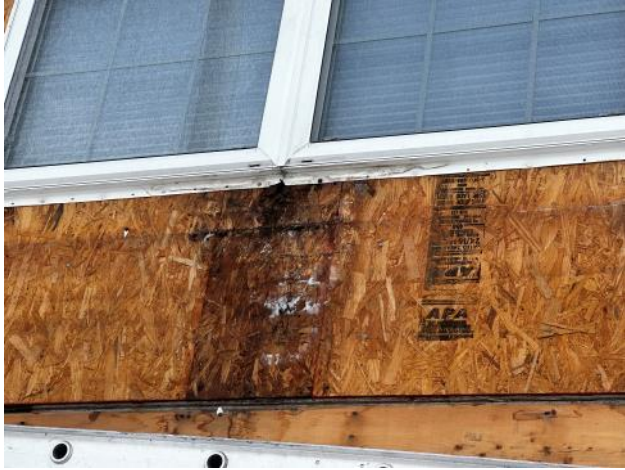
Photo #41: Overview of existing sheathing in poor condition below a box window at Unit 3.

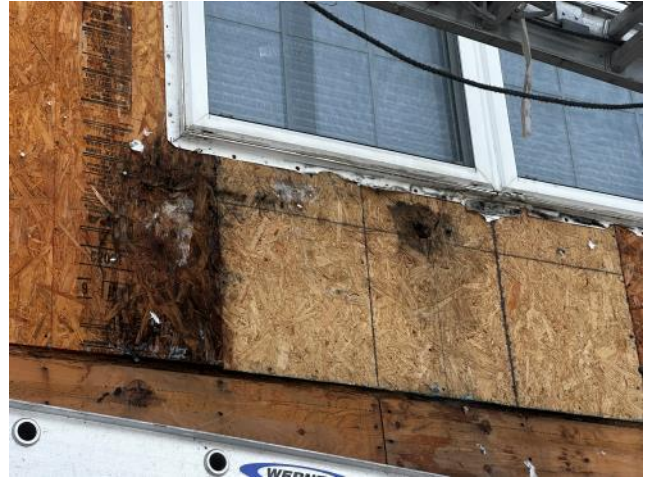
Photo #42: Overview of existing sheathing in poor condition below an upper window at Unit 3.

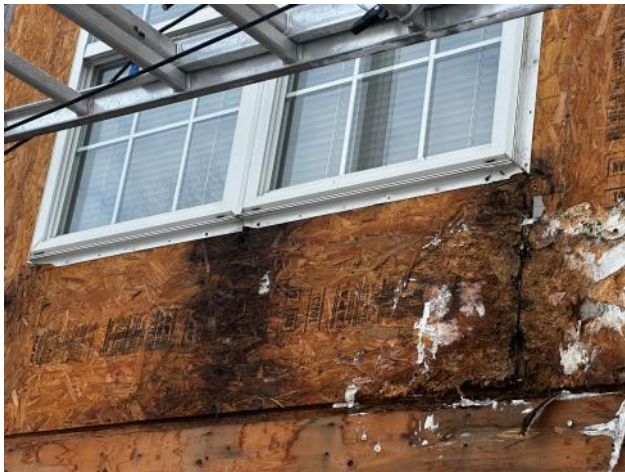
Photo #43: Overview of existing sheathing in poor condition below an upper window at Unit 33.

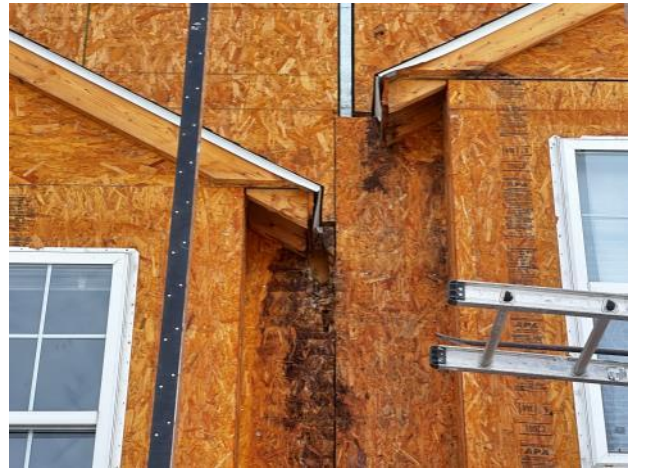
Photo #44: Overview of existing sheathing in poor condition below sections where kick-out flashings are needed.

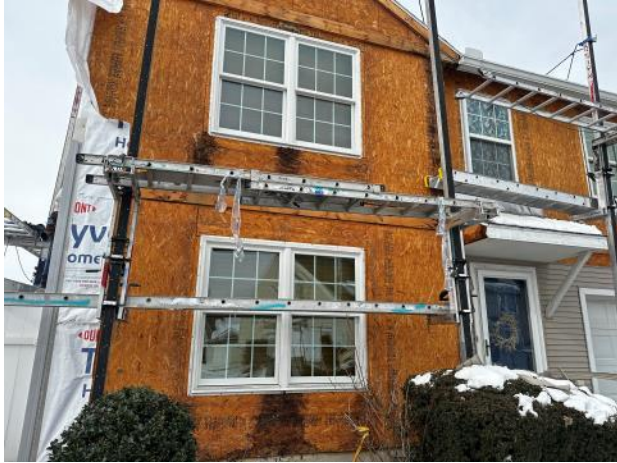
Photo #45: Overview of existing sheathing in poor condition below an upper and a lower window at Unit 31.

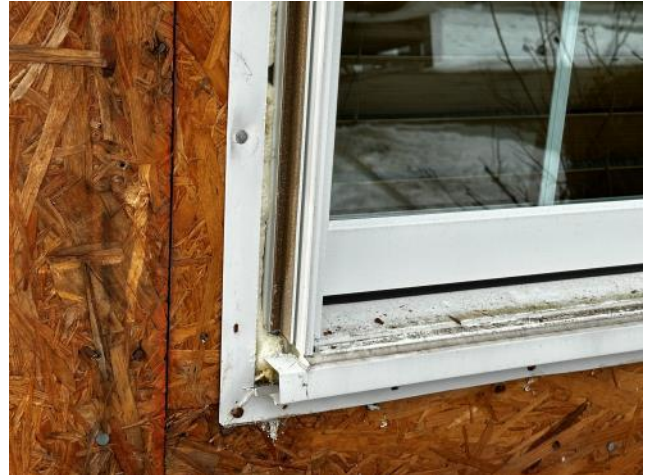
Photo #46: It should be noted that windows at Unit 31 were observed no to have a proper window flange.

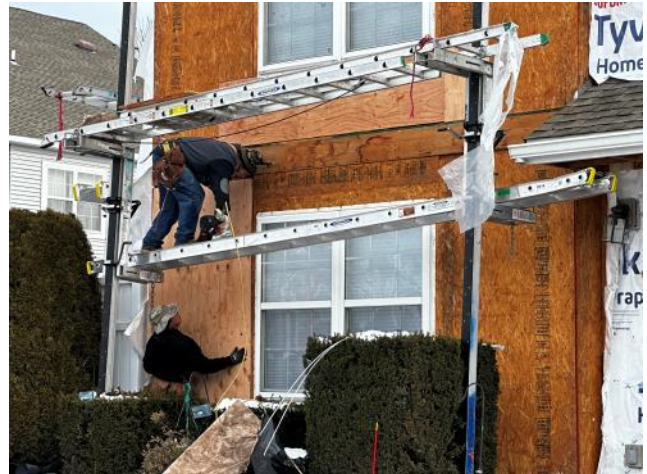
Photo #48: Overview of new sheathing being installed.

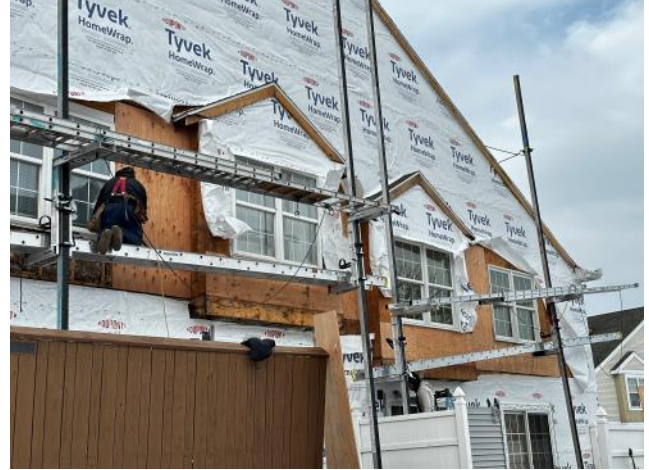
Photo #50: Overview of new sheathing being installed at the box windows.

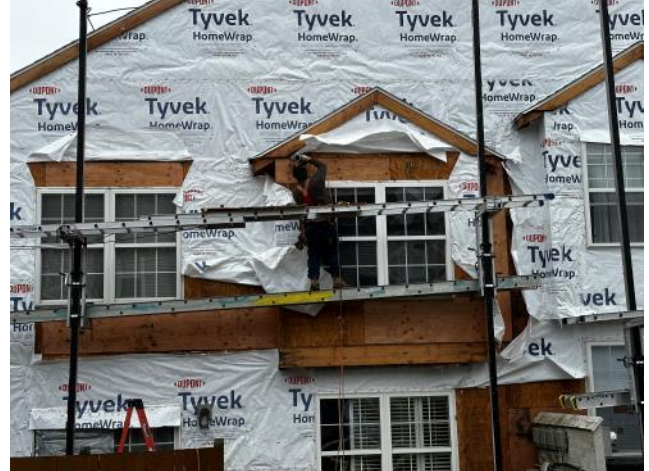
Photo #52: Overview of new sheathing being installed.

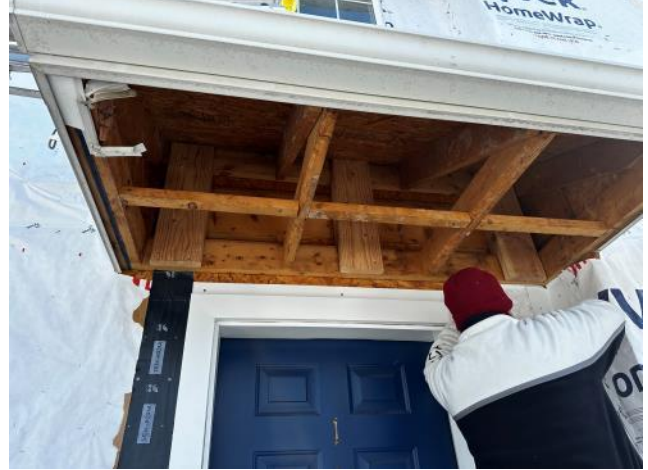
Photo #54: Overview of an entrance roof being reinforced with structural screws in order to eliminate the front brackets.

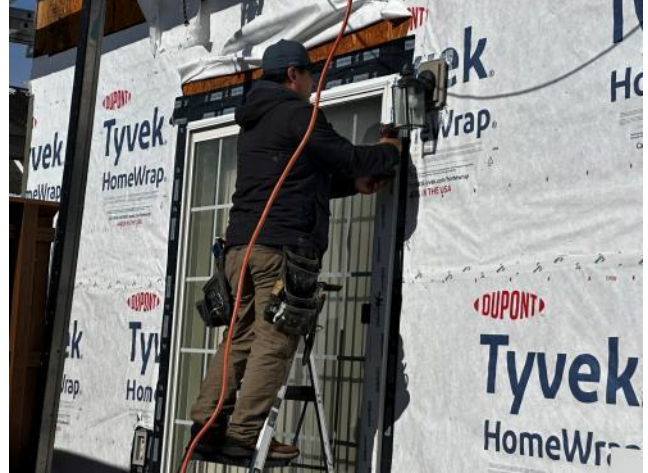
Photo #56: Overview of a sliding door being flashed.

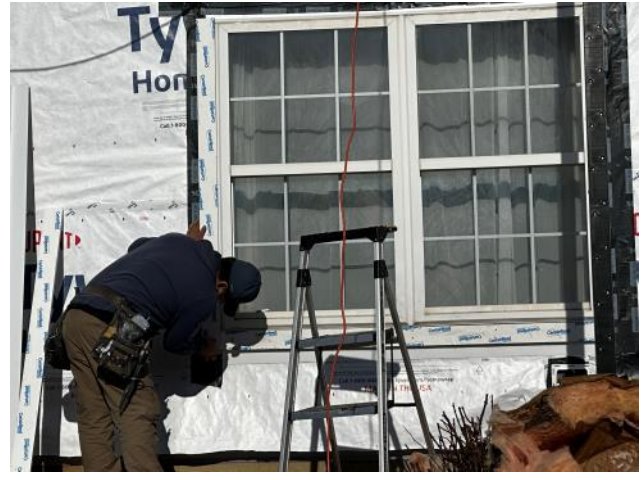
Photo #58: Overview of new pvc trim being installed at a window.

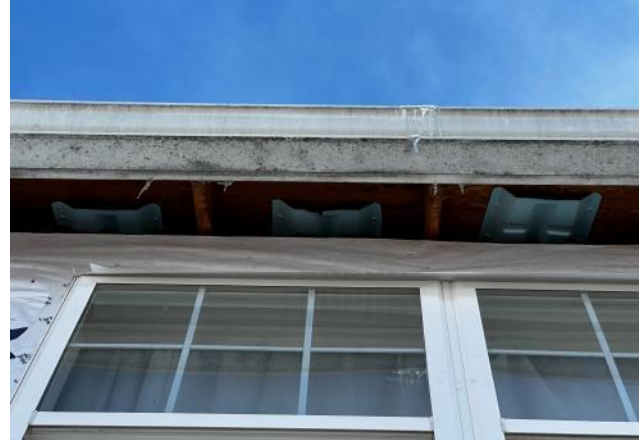
Photo #60: Overview of existing baffles observed in the Building.

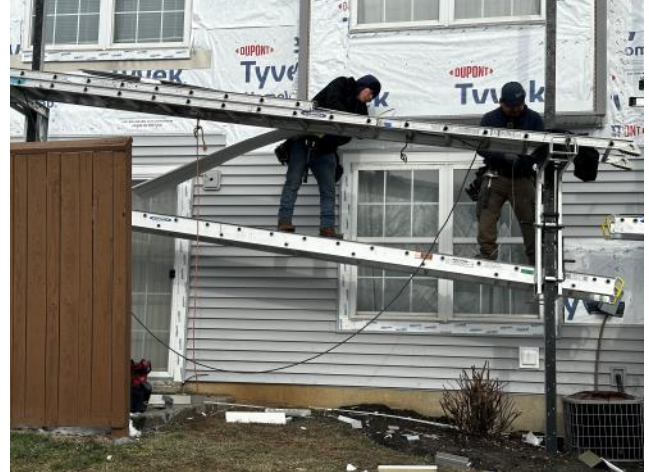
Photo #64: Overview of new vinyl siding being installed at a main side of the Building.

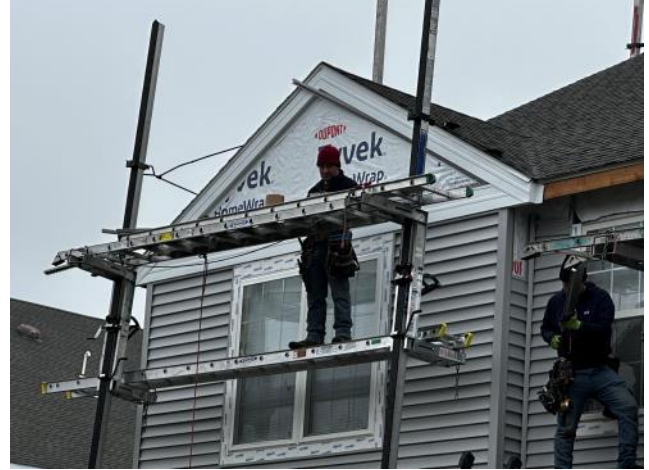
Photo #66: Overview of new vinyl siding being installed at a front small gable.

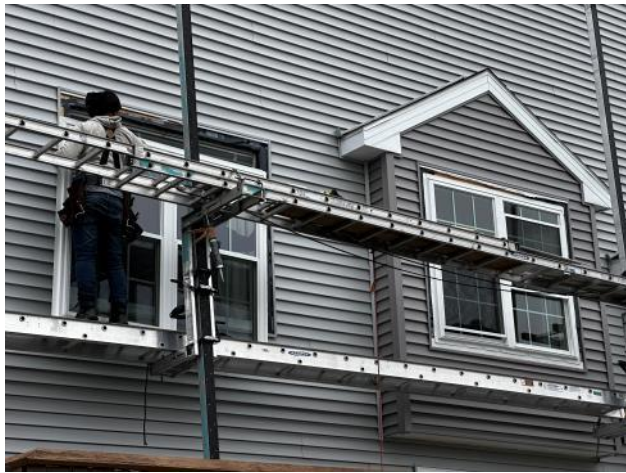
Photo #67: Overview of a new window being installed.

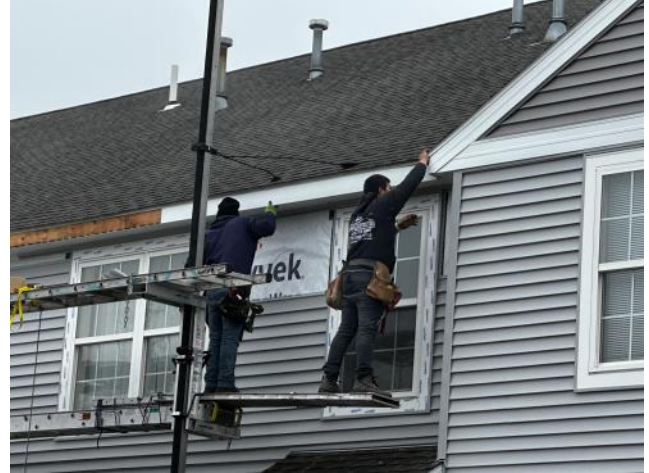
Photo #68: Overview of new metal wrap being installed at a fascia section.

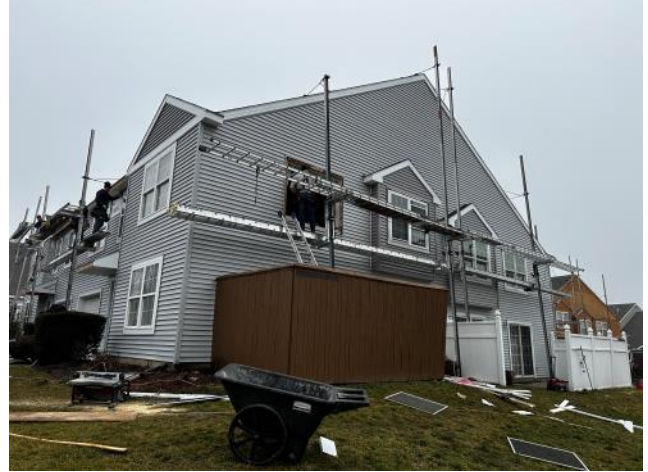
Photo #70: Overview of new vinyl siding being installed at a main side section.

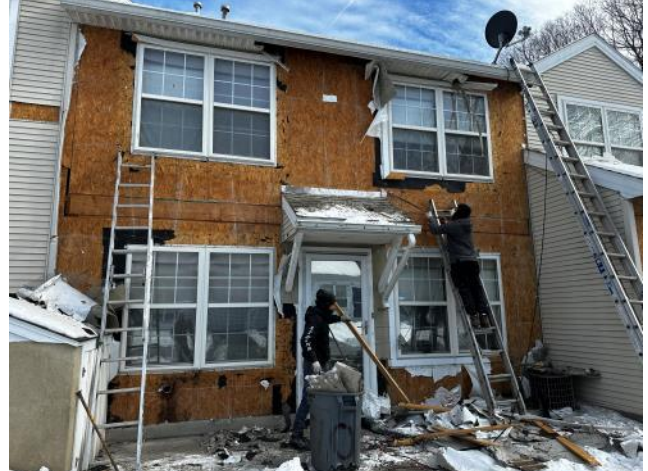
Photo #72: Overview of the demo crew removing the existing stucco.

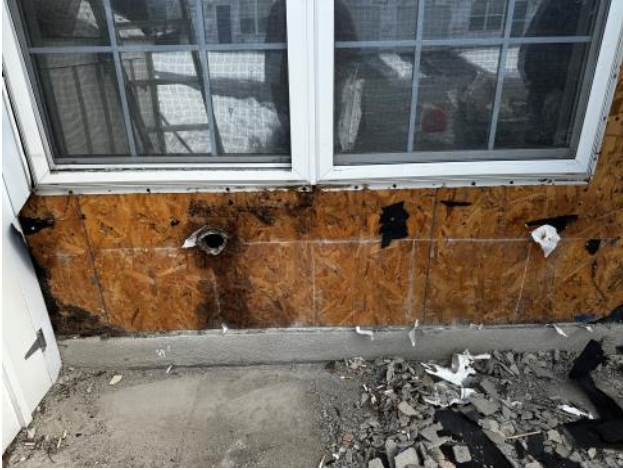
Photo #73: Overview of existing sheathing in poor condition below a lower window at Unit 16.

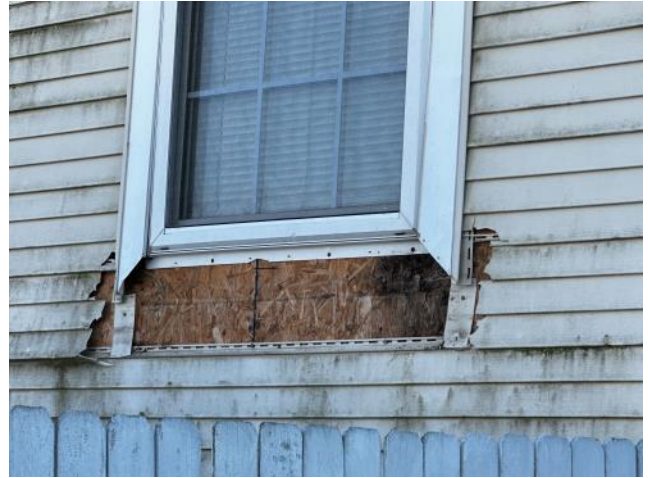
Photo #74: Overview of existing sheathing in poor condition below an upper window at Unit 8.

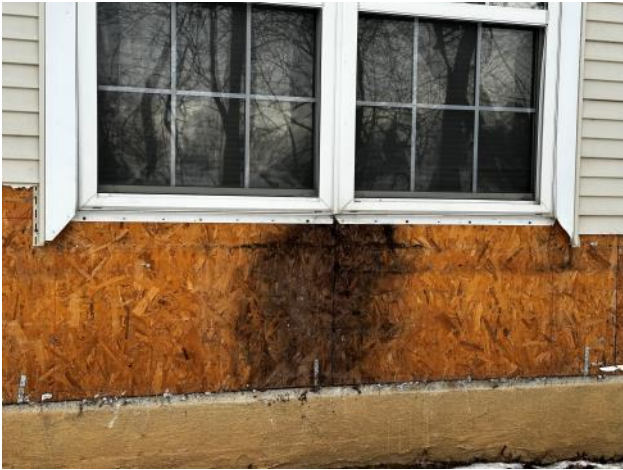
Photo #75: Overview of existing sheathing in poor condition below a box window at Unit 12.

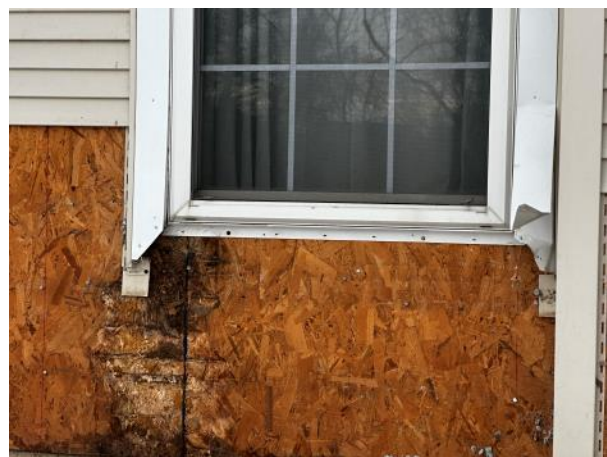
Photo #76: Overview of existing sheathing in poor condition below a lower window at Unit 12.

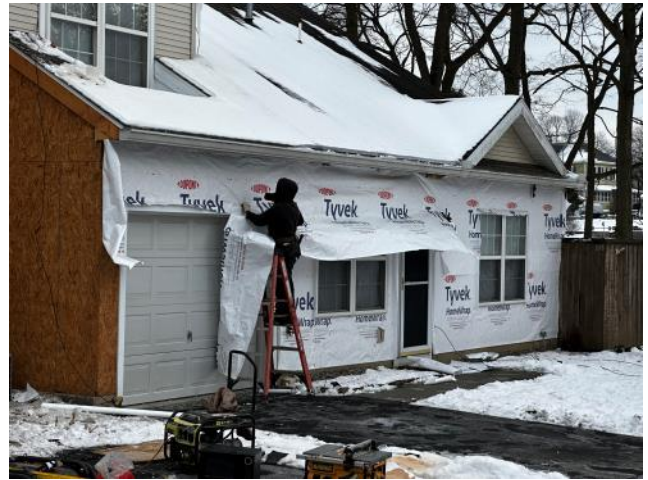
Photo #78: Overview of new Water Resistant Barrier (Tyvek) being installed.

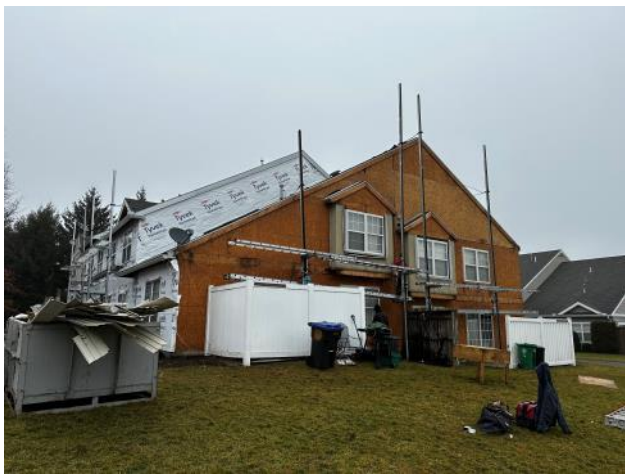
Photo #79: **Overview of Lemus Siding Crew (Green) working at Building 22 (19-29 Courtyard Drive).**

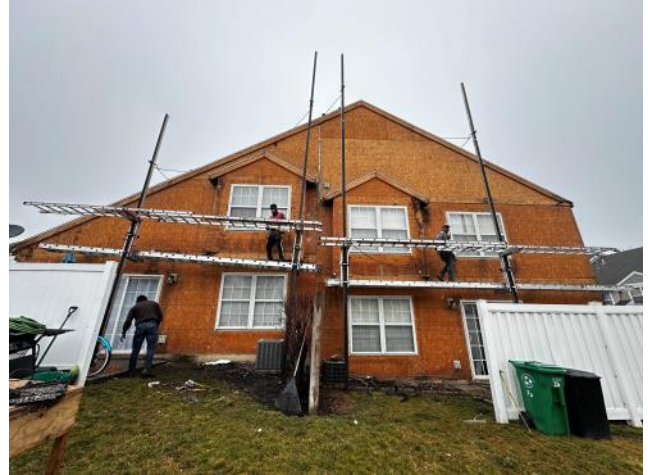
Photo #80: Overview of existing siding/stucco being removed. No Water Resistant Barrier was observed.

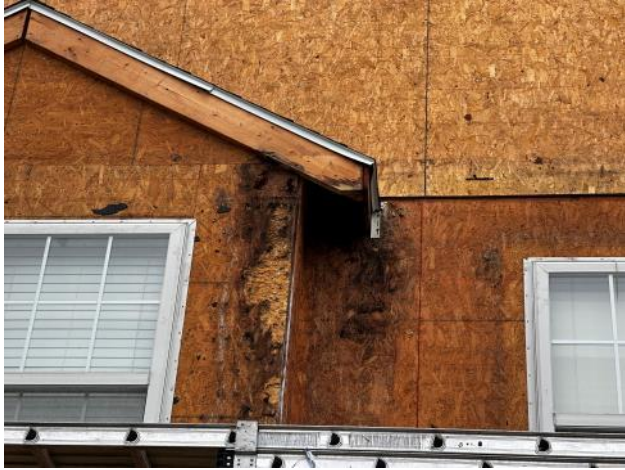
Photo #81: Overview of existing sheathing in poor condition below a section where a kick-out flashing is needed.

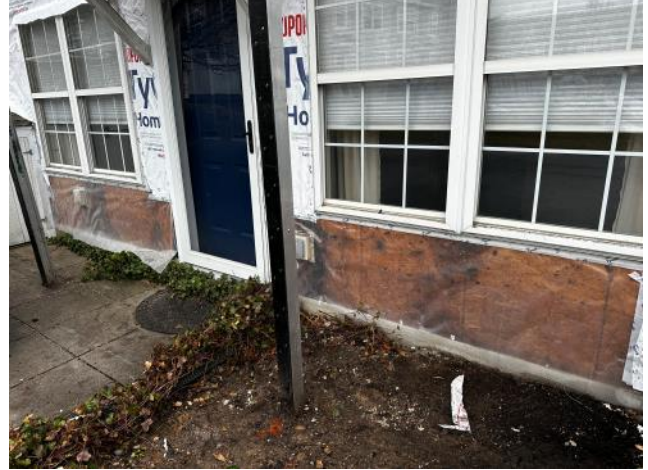
Photo #82: Overview of existing sheathing in poor condition below lower windows at Unit 27.

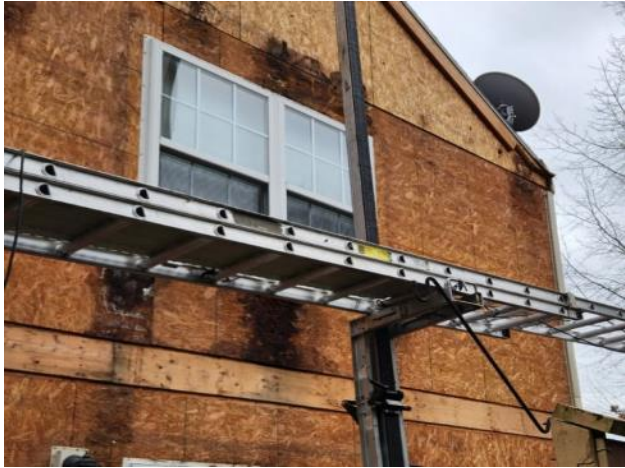
Photo #83: Overview of existing sheathing in poor condition below an upper window at Unit 29.

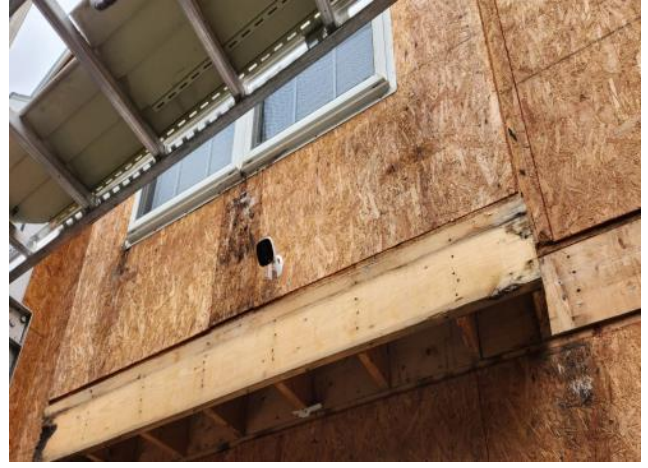
Photo #84: Overview of existing sheathing in poor condition below a box window at Unit 29.

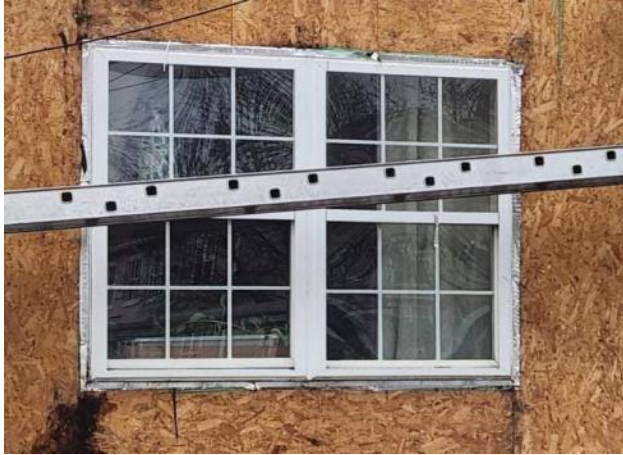
Photo #85: Overview of existing sheathing in poor condition below a lower window at Unit 25.

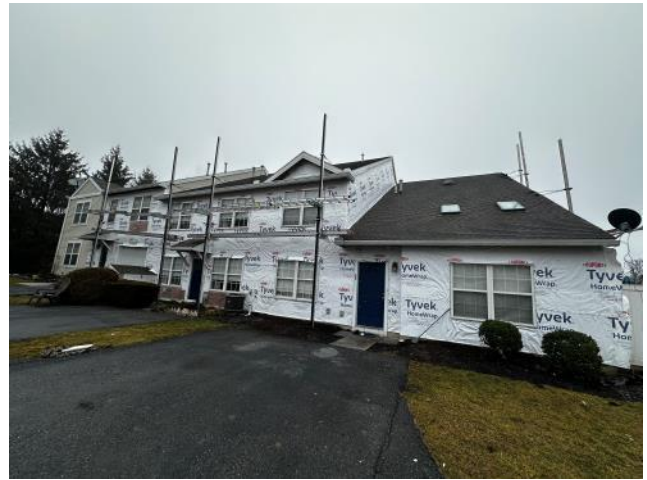
Photo #86: Overview of new Water Resistant Barrier (Tyvek) being installed.

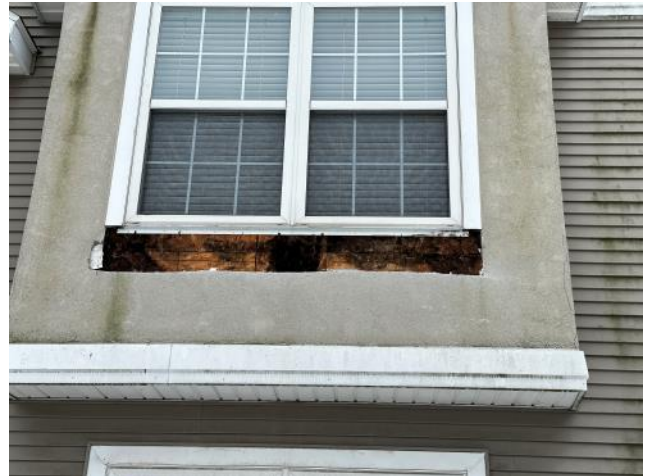
Also at the request of Lemus, small sections of the existing siding/stucco were removed below the existing windows at Building 1 (2-6, 1320-1324). This was done in order to identify which windows are failing due to this type of windows are smaller compared to the majority of the windows throughout the community. This way Lemus can communicate to the Homeowners if they opt to replace their damaged windows and Lemus can order them. The majority of the windows were observed to be failing, see photos below in the report.

Photo #88: Overview of existing sheathing in poor condition below a box window at Unit 2.

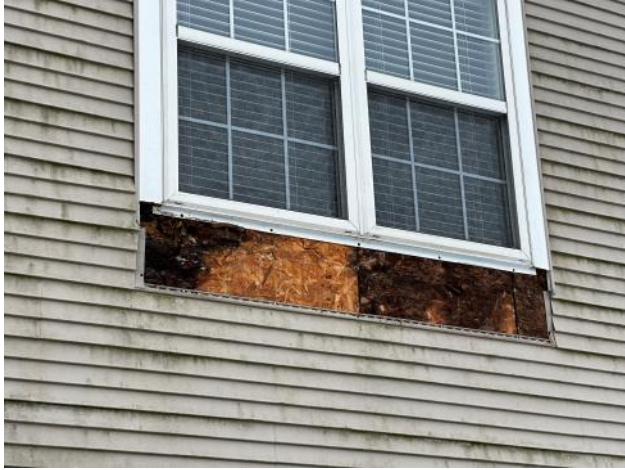
Photo #89: Overview of existing sheathing in poor condition below an upper window at Unit 2.

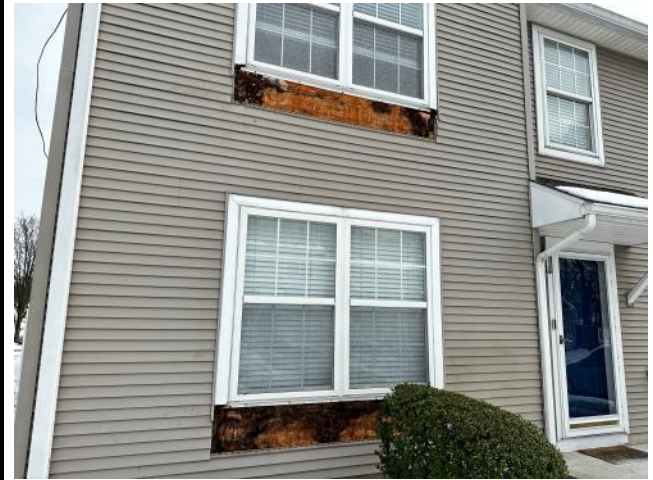
Photo #90: Overview of existing sheathing in poor condition below an upper and a lower window at Unit 2.

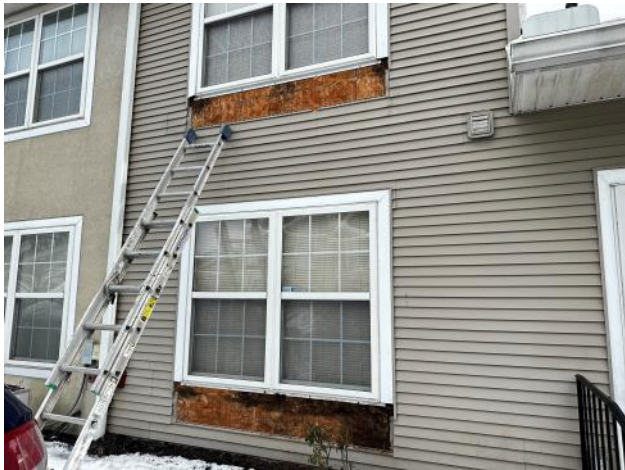
Photo #91: Overview of existing sheathing in poor condition below an upper and a lower window at Unit 6.

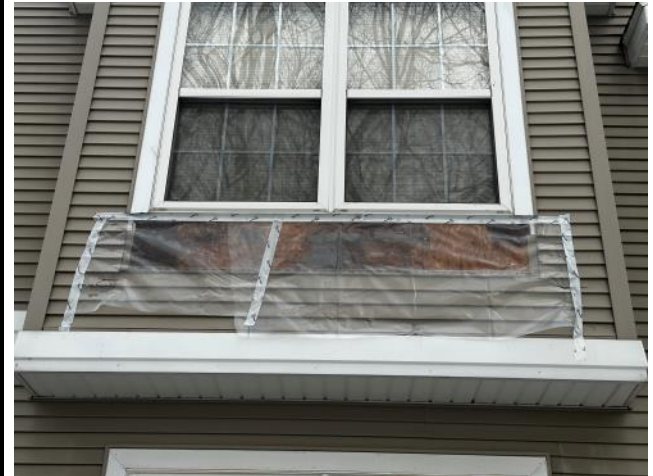
Photo #92: Overview of existing sheathing in poor condition below a box window at Unit 6.

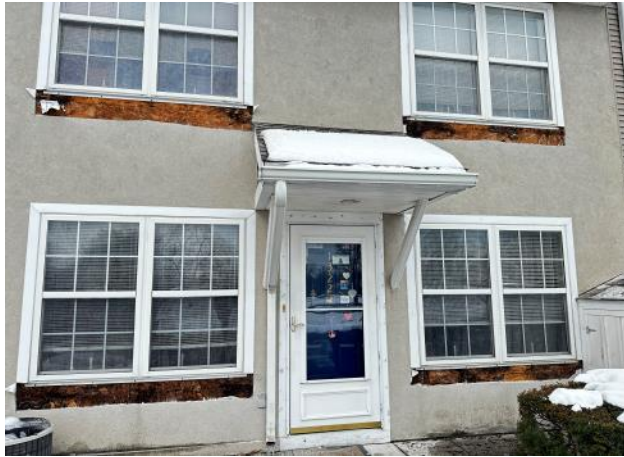
Photo #93: Overview of existing sheathing in poor condition below the four windows at Unit 1322.

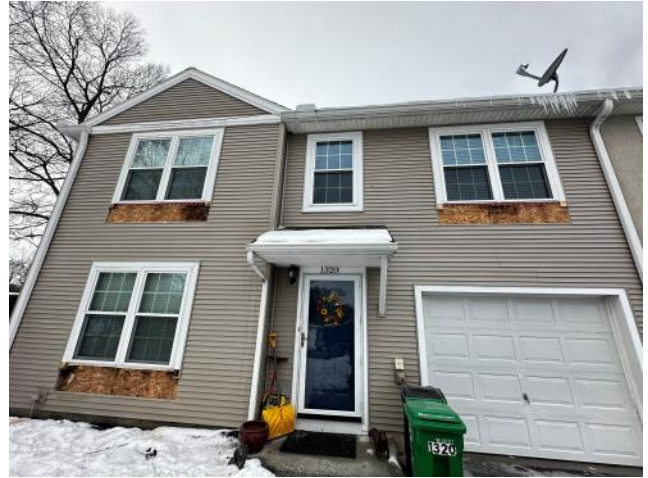
Photo #94: Overview of existing sheathing in poor condition below the front windows at Unit 1320.

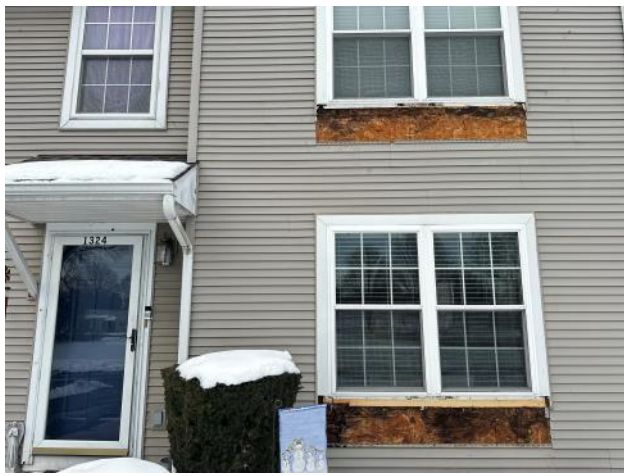
Photo #95: Overview of existing sheathing in poor condition below an upper and a lower window at Unit 1324.

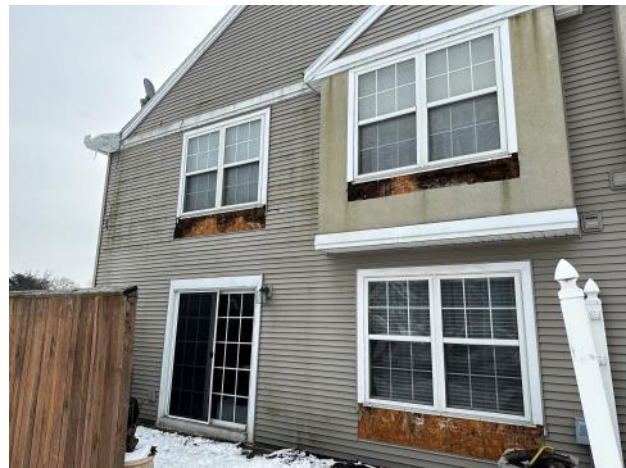
Photo #96: Overview of existing sheathing in poor condition below a box window and an upper window at Unit 1324.
