Project: Courtyards of Carlisle CA – Siding Project

Project #: 14372-04

Date: Jan 22, 23, 26, 27, 2024

Field Report 9

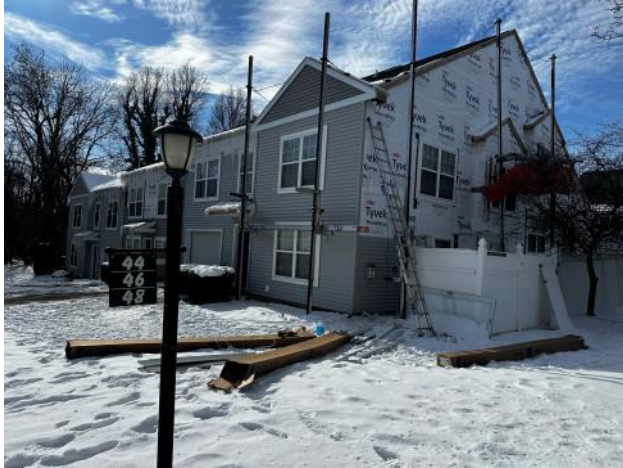
Photo #1: **Overview of Lemus Siding Crew (Blue) working at Building 5 (44-54 Courtyard Drive).**

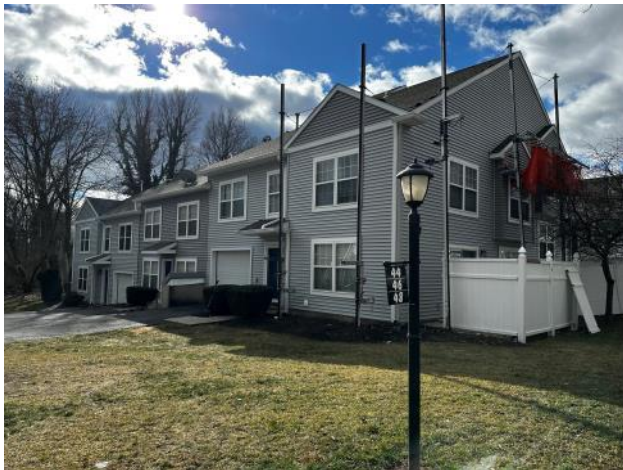
Photo #3: Overview of new vinyl siding installation completed at Building 5.

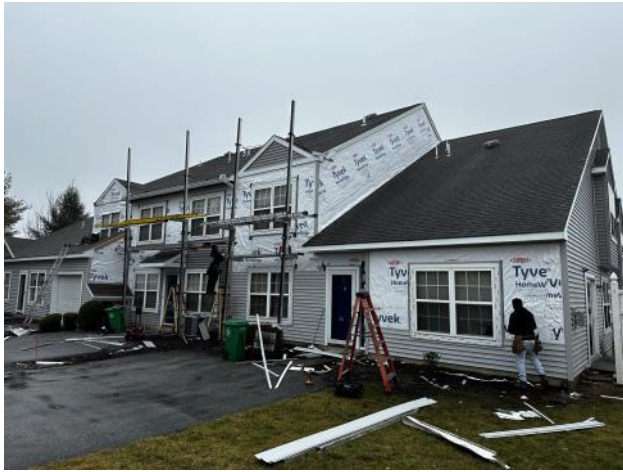
Photo #5: **Overview of Lemus Siding Crew (Yellow) working at Building 19 (19-29 Courtyard Lane).**

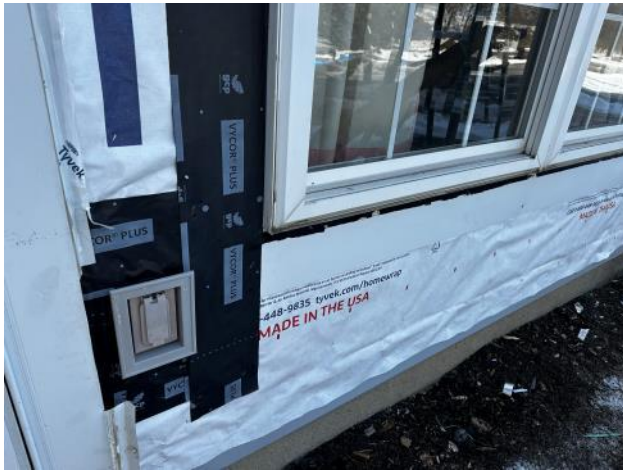
Photo #7: Overview of metal flashing installed at the bottom of a window and flashing tape installed as well.

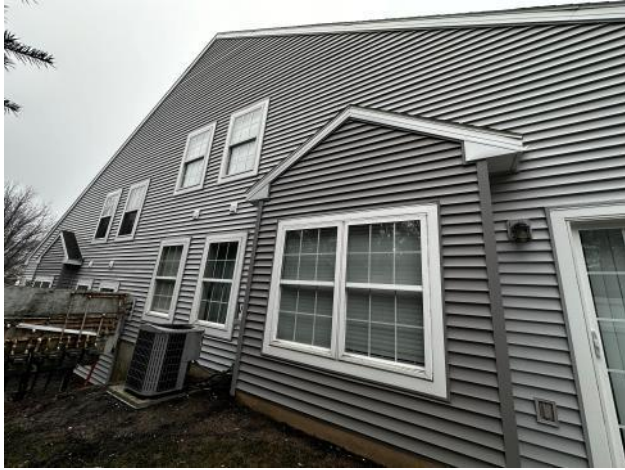
Photo #13: Overview of new vinyl siding installed at a main side of the Building.

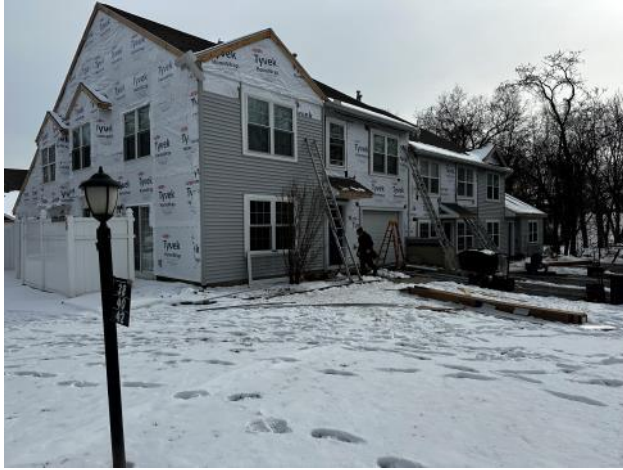
Photo #17: Overview of Lemus Siding Crew (Blue) working at Building 4 (32-42 Courtyard Drive).

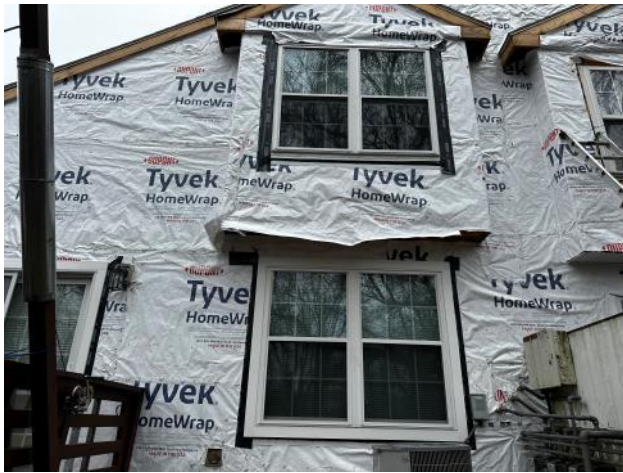
Photo #19: Overview of windows properly flashed and new pvc trim being installed.

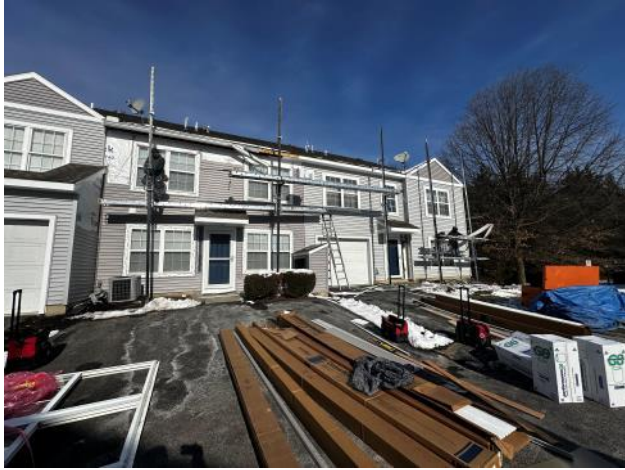
Photo #25: Overview of Lemus Siding Crew (Green) working at Building 20 (7-17 Courtyard Lane).

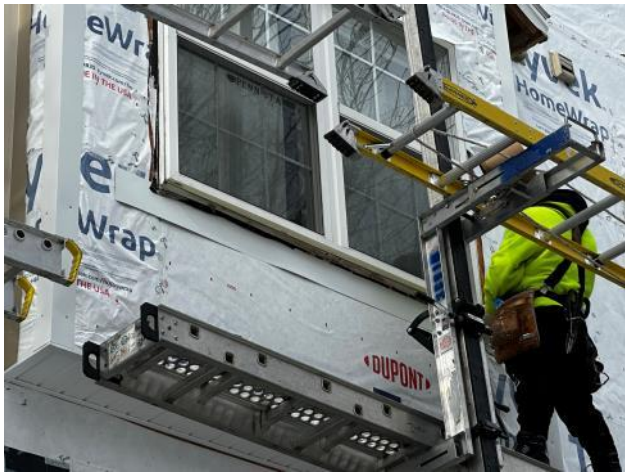
Photo #27: Overview of new metal flashing being installed at the bottom of a window.

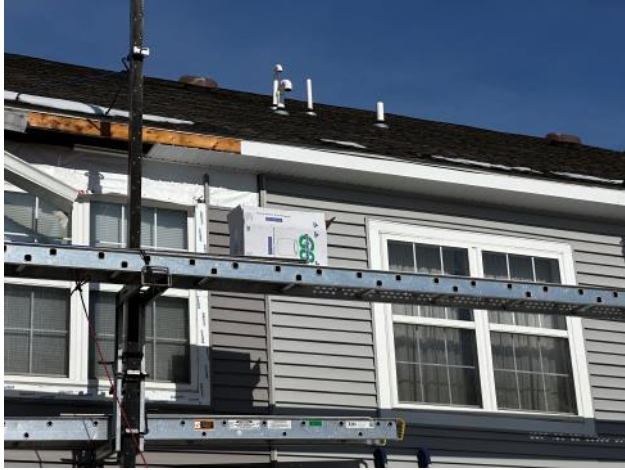
Photo #33: Overview of new intake soffit being installed.

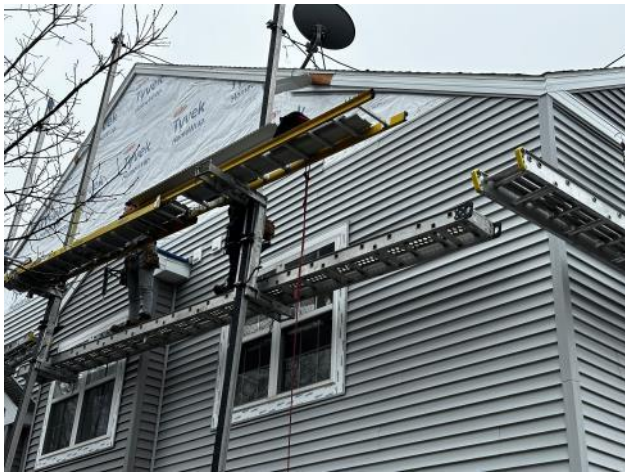
Photo #35: Overview of new vinyl siding being installed.

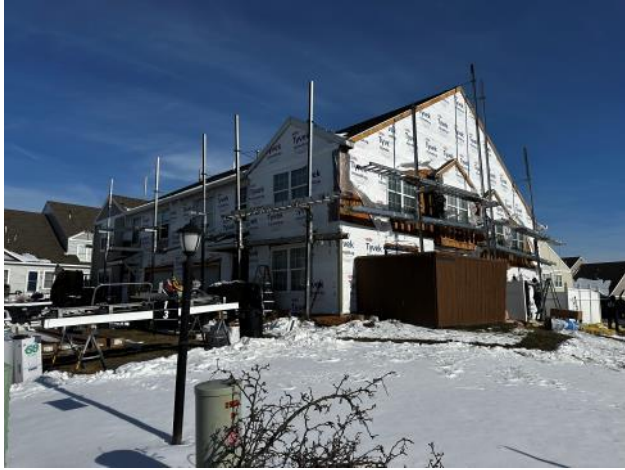
Photo #37: **Overview of Lemus Siding Crew (Yellow) working at Building 21 (1-3, 31-33 Courtyard Lane/Drive).**

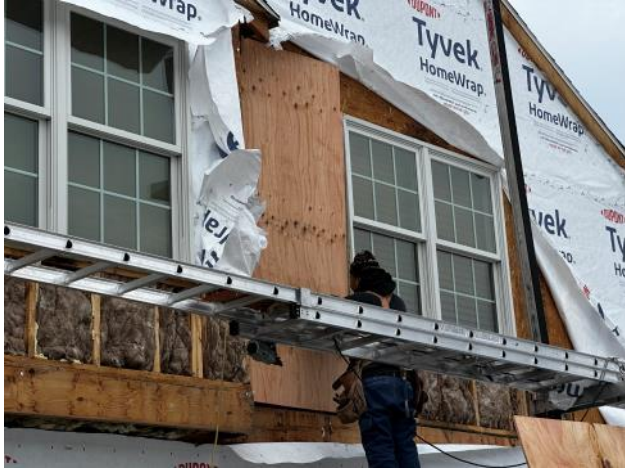
Photo #49: Overview of new insulation and new sheathing being installed.

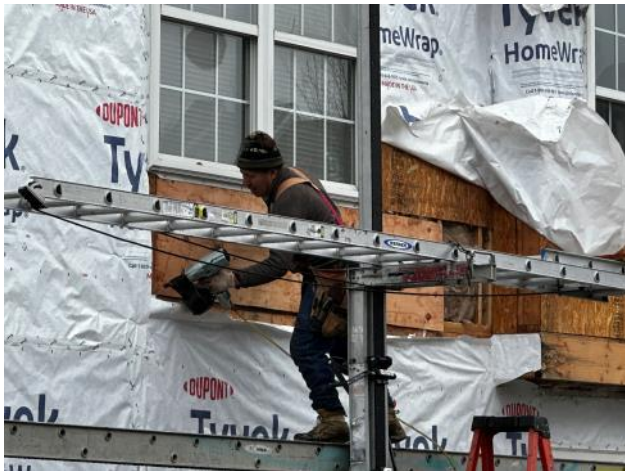
Photo #51: Overview of new sheathing being installed.

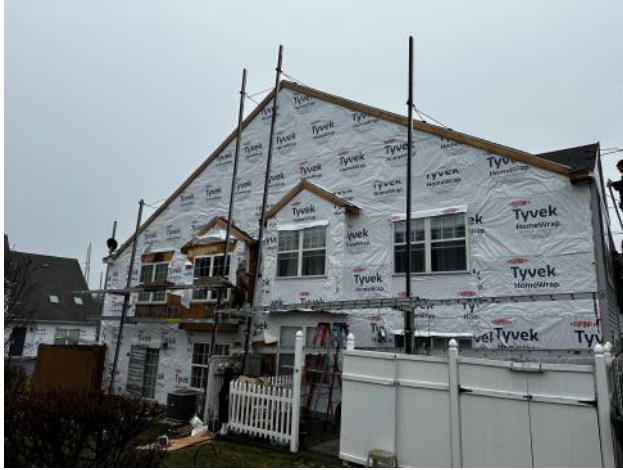
Photo #53: Overview of new Water Resistant Barrier (Tyvek) installed at a main side.

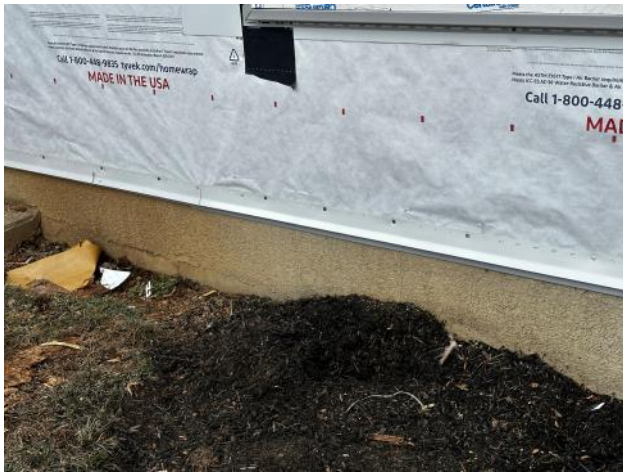
Photo #55: Overview of new starter strip being installed.

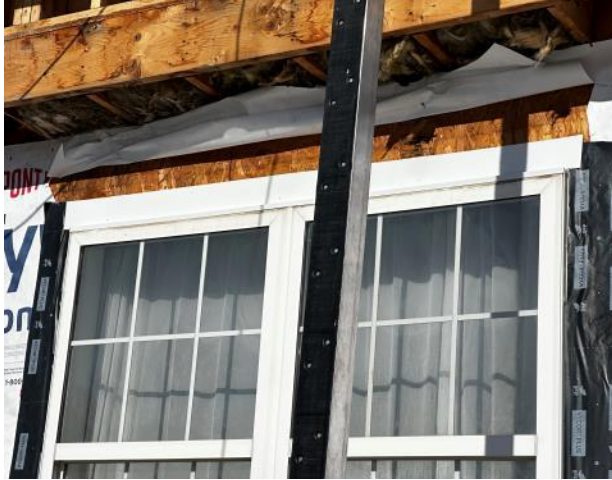
Photo #57: Overview of new metal drip cap being installed on a window.

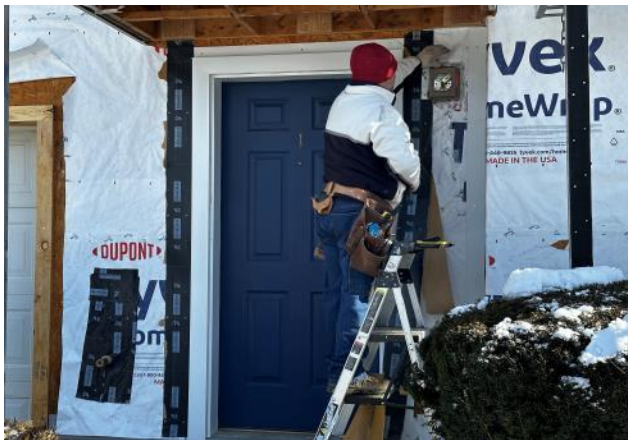
Photo #59: Overview of a front door being flashed.

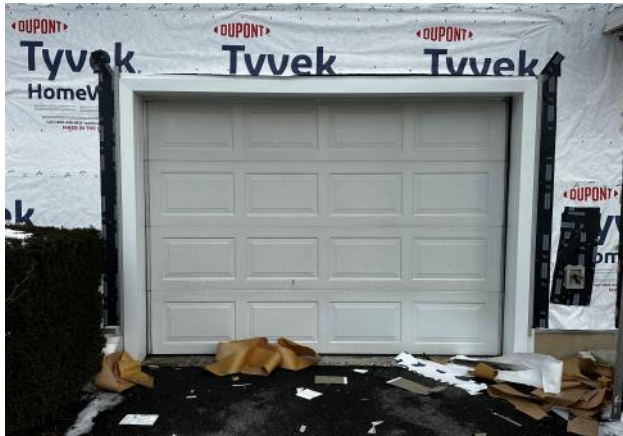
Photo #61: Overview of a garage door frame properly flashed.

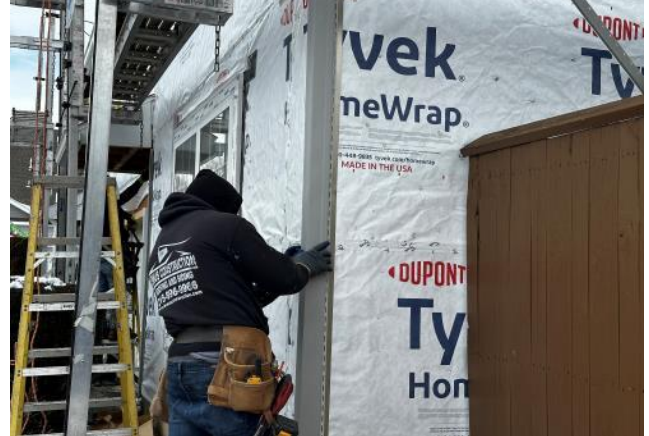
Photo #62: Overview of a new vinyl corner being installed.

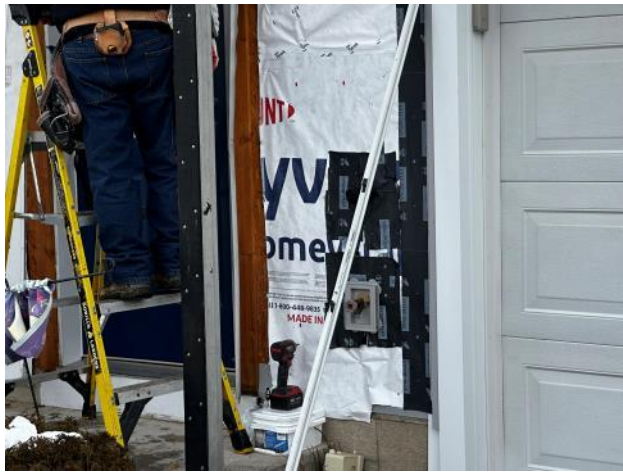
Photo #63: Overview of wall penetrations properly flashed.

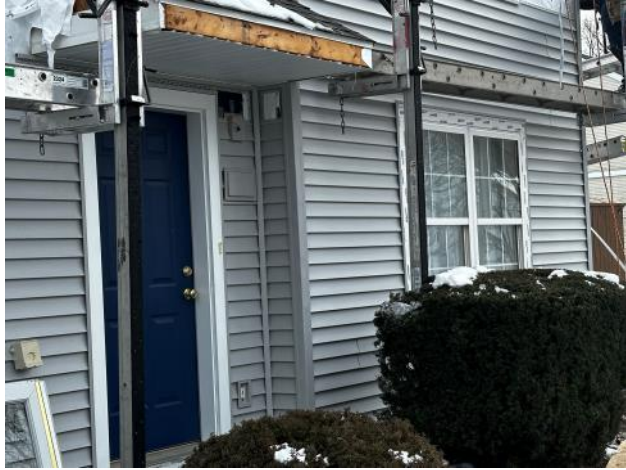
Photo #65: Overview of new vinyl siding being installed.

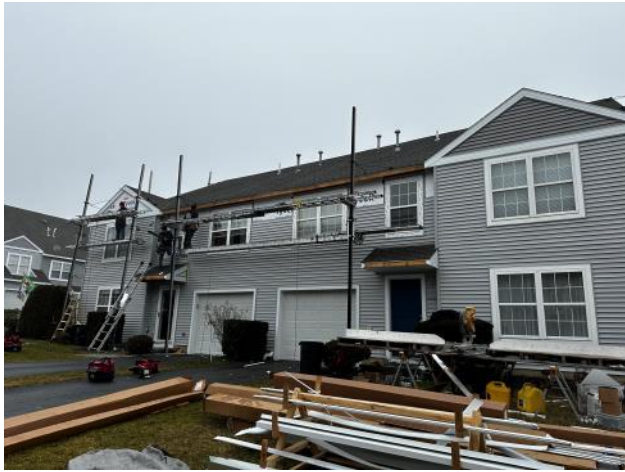
Photo #69: Overview of new vinyl siding being installed at a front section.

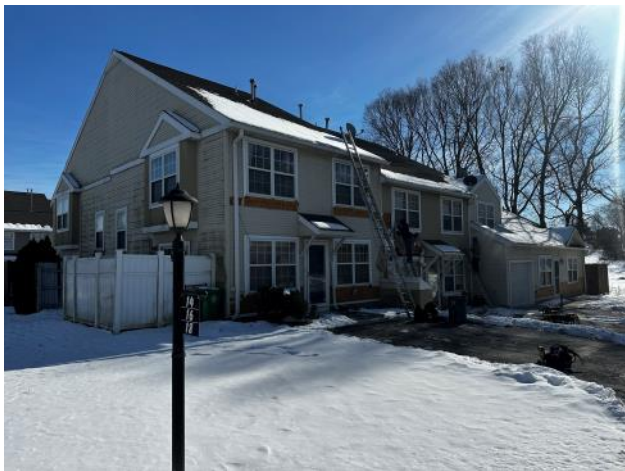
Photo #71: **Overview of Lemus Siding Crew (Blue) working at Building 2 (8-18 Courtyard Drive).**

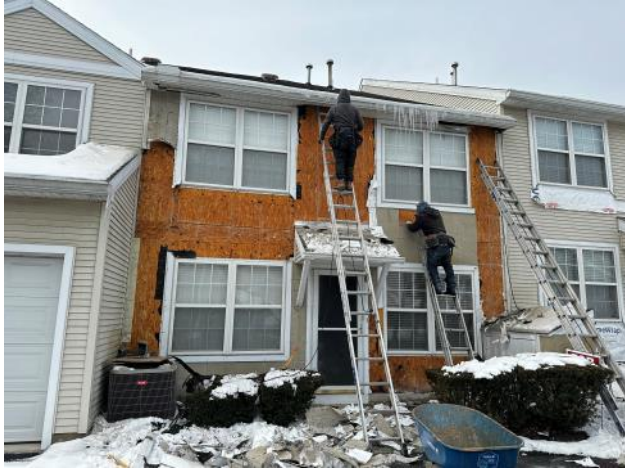
Photo #77: Overview of the demo crew removing the existing stucco at Unit 10.

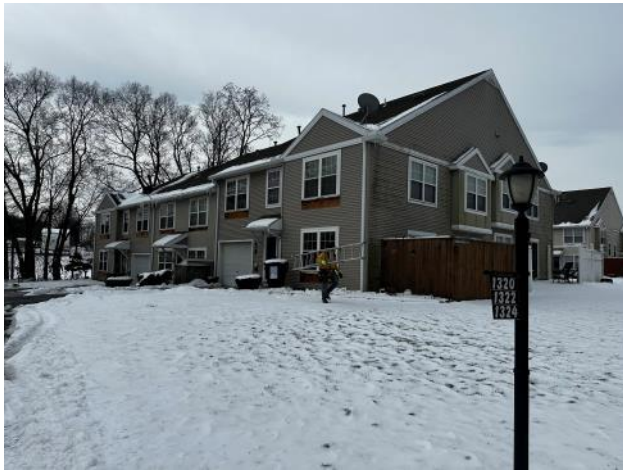
Also at the request of Lemus, small sections of the existing siding/stucco were removed below the existing windows at Building 1 (2-6, 1320-1324). This was done in order to identify which windows are failing due to this type of windows are smaller compared to the majority of the windows throughout the community. This way Lemus can communicate to the Homeowners if they opt to replace their damaged windows and Lemus can order them. The majority of the windows were observed to be failing, see photos below in the report.

Photo #87: Overview of Lemus removing small sections of the existing siding/stucco below the existing windows at **Building 1 (2-6, 1320-1324)**.
